# Ford Inova Fairfax Hospital CIREN Team

# A Case Study in Offset Frontal Collision

Vehicle #1: 1998 Chevy Lumina 4door

Vehicle #2: 1999 Honda Civic 2door

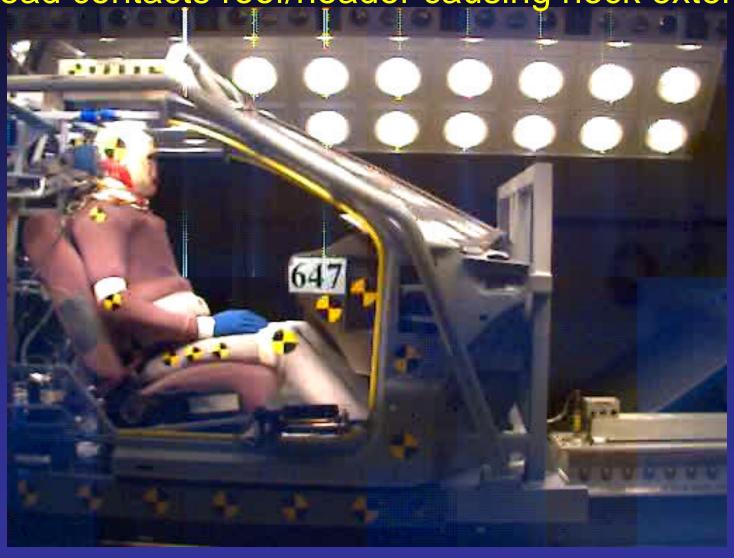
#### Cadaver, lap belt, airbag, 56 km/h frontal pulse

Head contacts roof/header causing neck extension

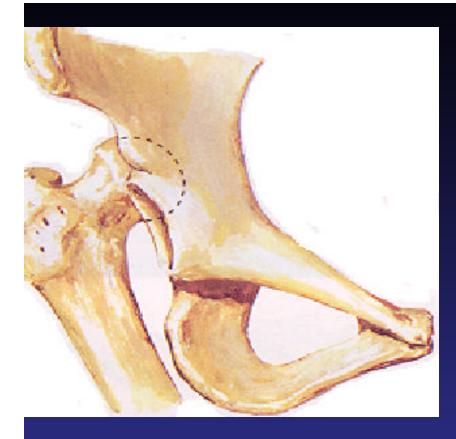
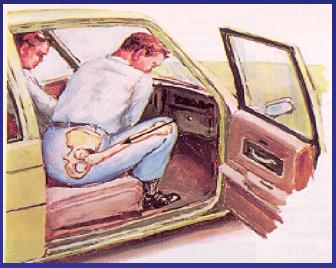
THIGH FLEXED AND ABDUCTED

FRACTURE OF FEMORAL SHAFT AND/OR CONDYLAR FRACTURES

DISLOCATION OF PROXIMAL FEMUR AND/OR SHEARED HEAD OF FEMUR THIGH FLEXED AND ADDUCTED

C ACETABULAR FRACTURE OR

D POSTERIOR DISLOCATION OF FEMUR

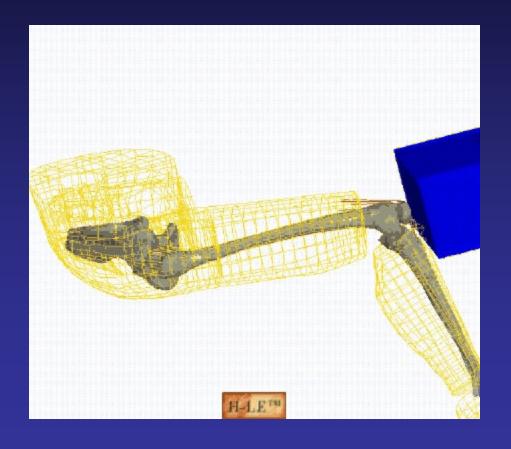
#### Hip Dislocation

left hip dislocation
